Contract #: 04-0120F4Cty: SF/ALA Rte: 80 PM: 13.2/13.9File #: 69.28**WELDING INSPECTION REPORT****Resident Engineer:**Siegenthaler, Peter**Address:** 333 Burma Road**City:** Oakland, CA 94607**Report No:** WIR-023210**Date Inspected:** 01-May-2011**Project Name:** SAS Superstructure**OSM Arrival Time:** 700**Prime Contractor:** American Bridge/Fluor Enterprises, a JV**OSM Departure Time:** 1900**Contractor:** Zhenhua Port Machinery Company, Ltd (ZPMC), Changxing Island **Location:** Shanghai, China**CWI Name:** An Qing Xiang**CWI Present:** Yes No**Inspected CWI report:** Yes No N/A**Rod Oven in Use:** Yes No N/A**Electrode to specification:** Yes No N/A**Weld Procedures Followed:** Yes No N/A**Qualified Welders:** Yes No N/A**Verified Joint Fit-up:** Yes No N/A**Approved Drawings:** Yes No N/A**Approved WPS:** Yes No N/A**Delayed / Cancelled:** Yes No N/A**Bridge No:** 34-0006**Component:** OBG**Summary of Items Observed:**

TA YARD, OBG 14E (NWIT # 09000)

OBG Seg 14W:

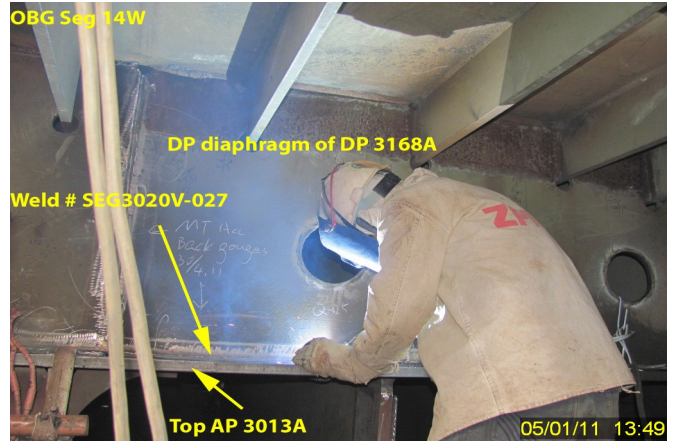
The FCAW process on weld joint no: SEG3020V-027 [DP diaphragm of DP 3168A to top anchorage plate (AP) 3013A, CJP weld at PP 125]. The welder is identified as 066881 and was observed welding in 2G position. ZPMC QC was identified as Mr. Zhu Lin. The welding variables recorded by this QC appeared to comply with WPS: B-T-2232-ESAB. Attached photograph provide additional details.
